Analysis Report

**REPORT NUMBER:
924980.2**

Item: Analysis of emission of ozone from UV box during use

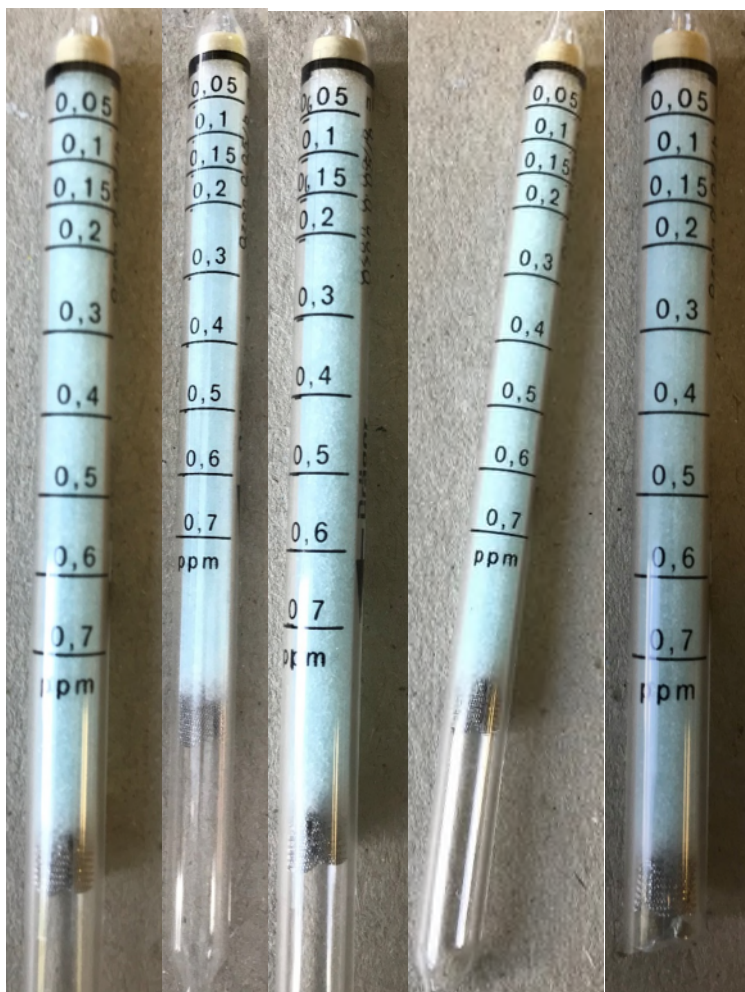
If ozone is present, then the short-term tubes will change colour from light blue to white.

The tubes from the measurements were equal to the background measurement showing that the UV box does not cause any ozone emission.

Figure 1: Short-term tubes after measurements in the following order from left to right: Unused tube, background measurement, measurements during use of the UV box, cycle 1-3.
